National Transportation Safety Board Aviation Accident Final Report

Location:	Bartow, FL	Accident Number:	CEN18FA061
Date & Time:	12/24/2017, 0717 EST	Registration:	N247AT
Aircraft:	CESSNA 340	Aircraft Damage:	Destroyed
Defining Event:	Loss of control in flight	Injuries:	5 Fatal
Flight Conducted Under:	Part 91: General Aviation - Personal

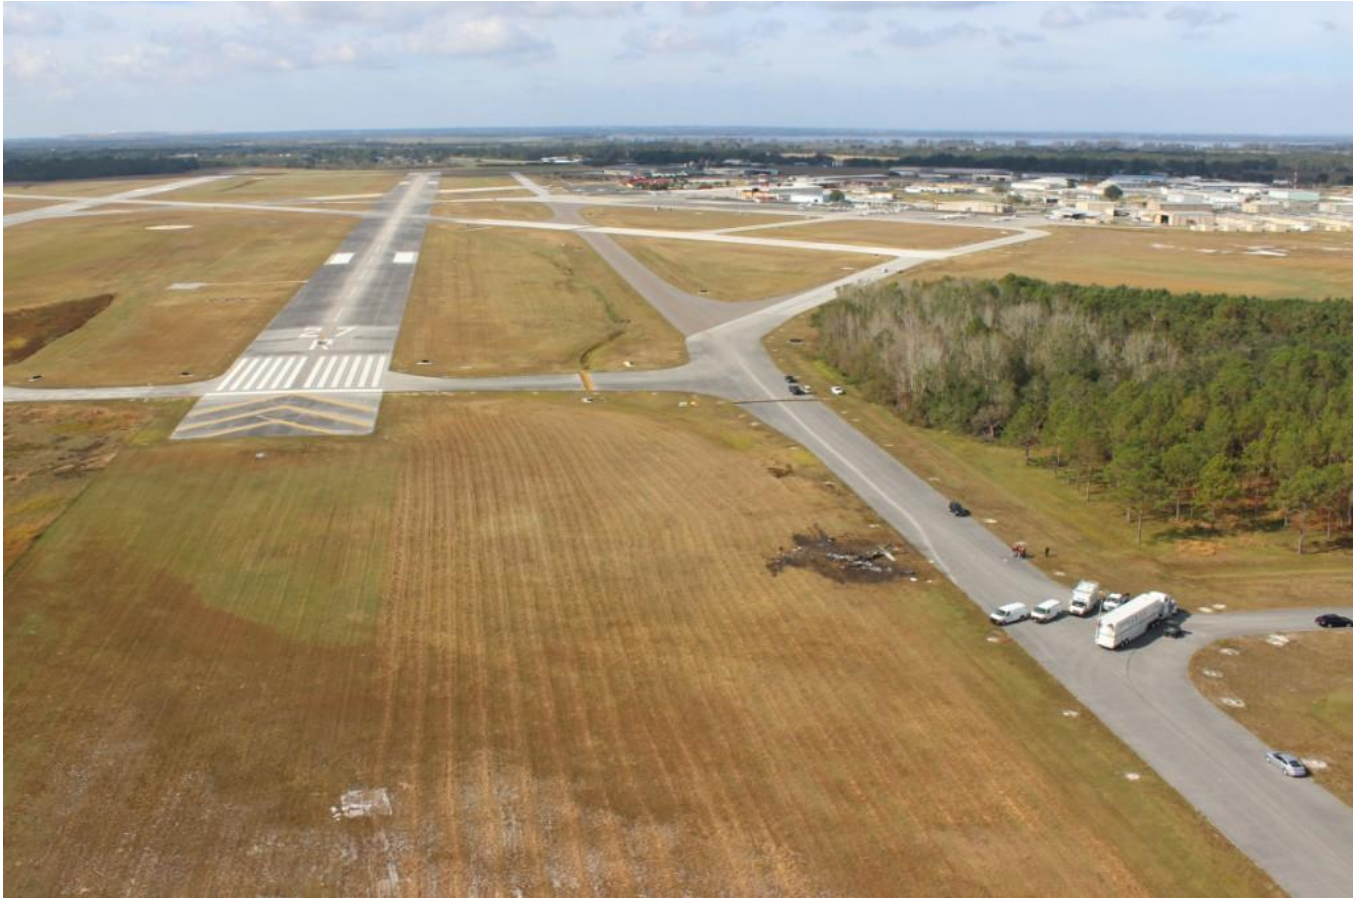
Figure 1 – Aerial View of Accident Site

The accident site was located on airport property about 190 yards east-northeast of the departure end of runway 9L and 10 ft south of taxiway delta (figure 1).

The debris path was about 230 ft long and oriented northeast. The beginning of the debris path was defined by several ground impact craters in a line perpendicular to the debris path and the main wreckage. The middle impact crater contained pieces of the airplane's nose cowl and baggage door. Immediately to the right was the left engine's propeller. To the left of the middle crater was the right engine's propeller. A portion of the left wing tip fuel tank was found on the far right side of the initial impact area, and a portion of the right wing tip fuel tank was found on the far left side of the initial impact area. The main wreckage came to rest upright and oriented southeast about 30 ft from the initial impact craters. The fuselage was mostly consumed by fire and the empennage remained mostly intact with significant thermal damage. Both engines separated from the airplane and came to rest near the main wreckage. Airplane debris was found on the taxiway northeast of the main wreckage. The nose landing gear was separated from the airplane and found about 200 ft northeast of the main wreckage.

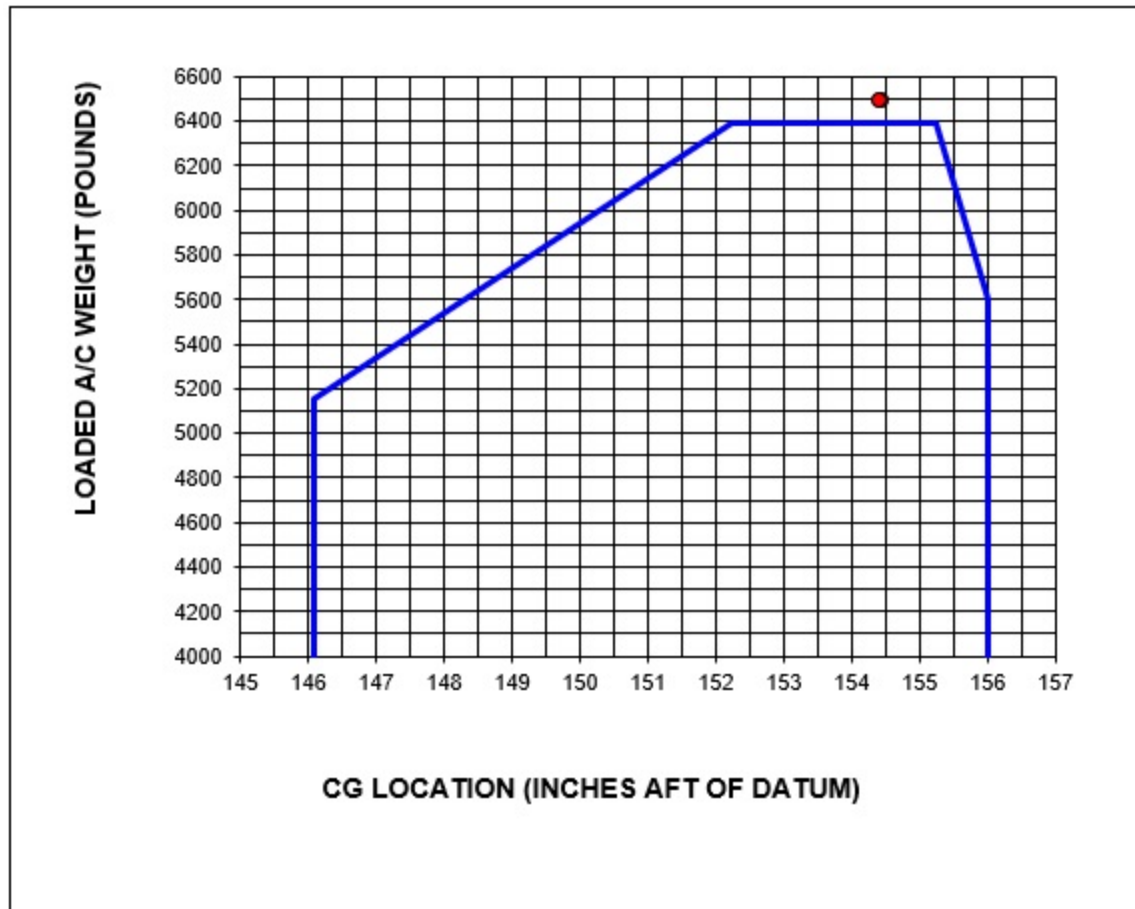
Figure 3 – Center of Gravity Moment Envelope

The airplane's maximum gross takeoff weight was 6,390 lbs. The weight at the time of the accident takeoff was about 6,495 lbs, about 105 lbs over the maximum takeoff weight (figure 2). Due to the excessive weight, the airplane was outside of its center of gravity moment envelope (figure 3).
